Design Review Of Leuwikeris Dam Acces Road Pakage 4

Reki Arbianto^{1*}, Gunarso²

ABSTRACT

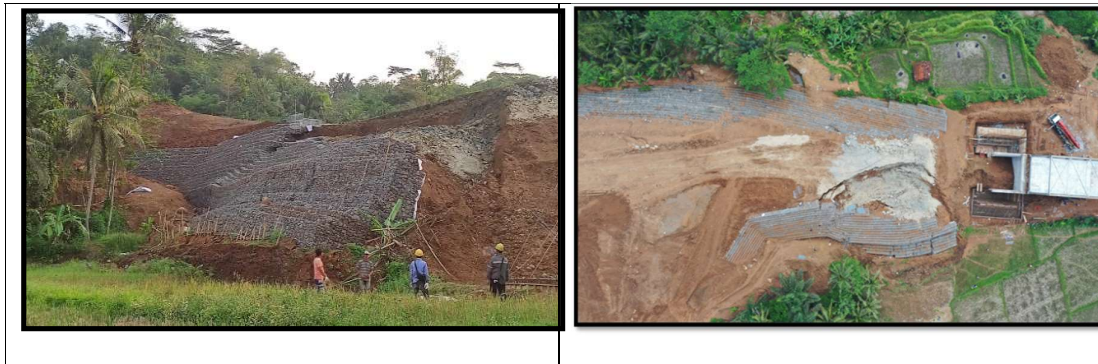
Fig. 1. Research Location.

This design review was carried out because a landslide occurred on one of the embankment slopes which did not rule out the possibility that it could occur on the opposite slope. The picture above shows a general failure from top to bottom, this is evidenced by the fact that the Gabion has been lifted to the ground. This could be due to the

fact that the lower gabion foundation structure did not penetrate the landslide area, resulting in a collapse.

collapse starts from under the foundation and then collapses above it. This can be seen in the existing photo (Figure 1). The gabion foundation is lifted to the ground level.

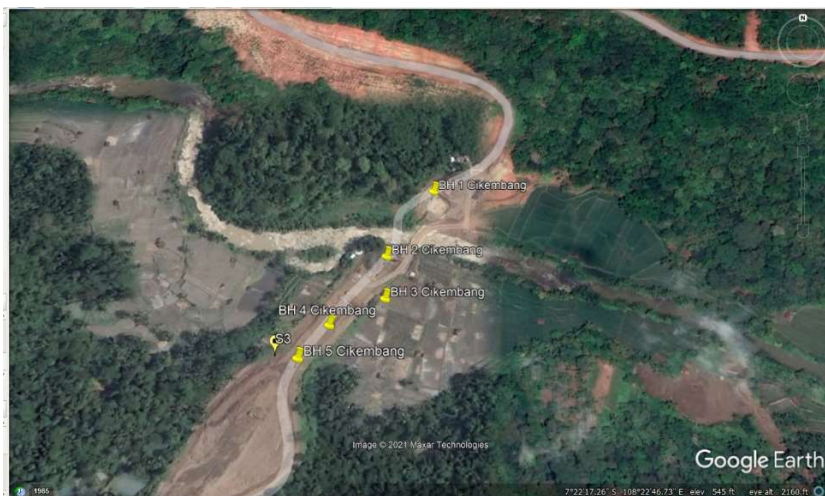
Figure 4. Deep Drill and Sondir Test Locations

Modeling of soil and gabion materials in numerical simulations uses the Mohr-Coulumb Material Model. Determination of soil parameters and reinforcement material parameters requires data analysis, based on the results of field tests, as well as from laboratory tests. Field testing includes 5 deep drill points with varying depths of BH 1 (30m), BH 2 (42 m), BH 3 (30 m), BH4 (30m), BH 5 (30 m). In addition, a 3-point sondir test was also carried out. Laboratory testing is carried out on embankment soil including index properties, direct shear test and standard proctor. The locations for field testing are as follows:

The landslide location is located in the area at the S3 and BH 5 positions, so the data we use is at that point. The results of the stratigraphy of the soil investigation are shown in the following figure:
